MARINE INVESTIGATION REPORT

M99W0058

STRIKING BOTTOM

**THE BULK CARRIER "CAPE ACACIA"
WEST KINAHAN ISLAND, PRINCE RUPERT HARBOUR
9 APRIL 1999**

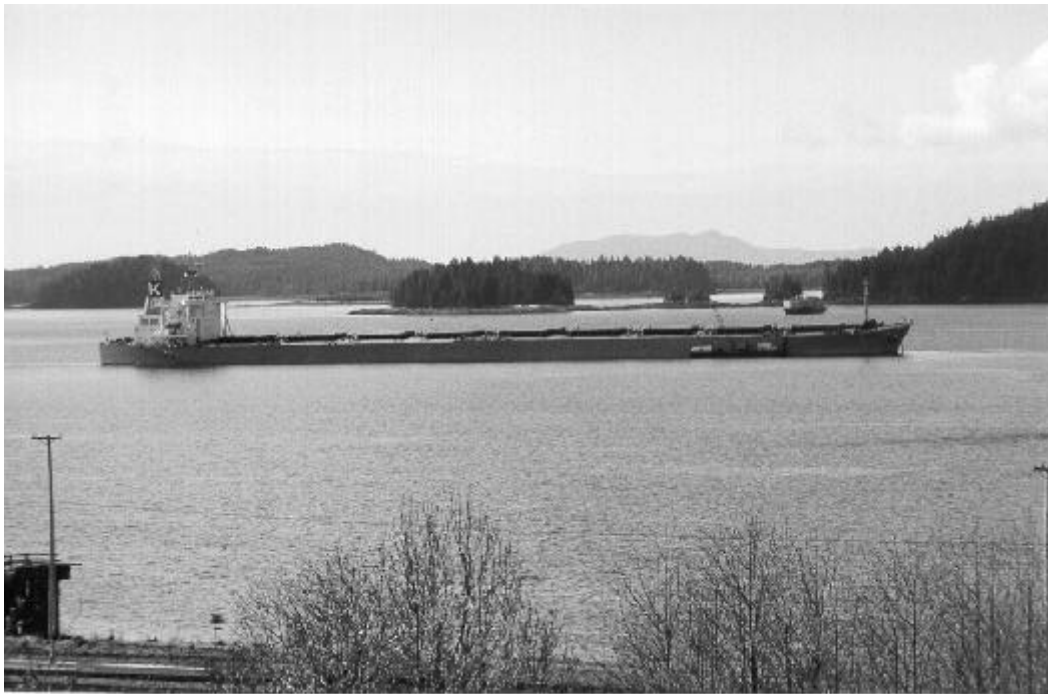
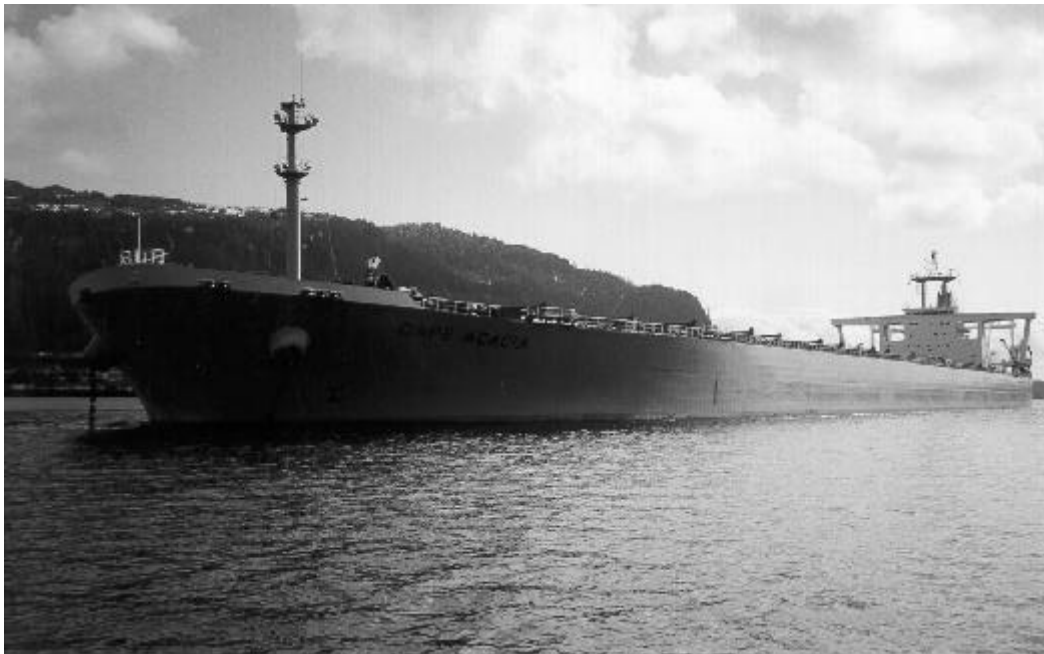
Appendix B - Photographs

Damage was limited to the forward underwater section of the vessel. The bottom shell plating in way of the forepeak tank (FPT) had a number of holes and tears, with a maximum size of approximately 5 m x 2 m. The bottom shell plating in way of No. 1 DBWBT had three holes with a maximum size of 700 mm x 150 mm. The collision bulkhead between the FPT and No. 1 starboard DBWBT had cracks at the connection to the bottom strake. Additional denting and scratching was found at the bow section.

5. The "CAPE ACACIA" struck a rocky bottom south of West Kinahan Island, immediately inside the 20 m contour line, during darkness, in fine weather and clear visibility. The starboard underwater section of the bow was badly damaged.
